Manhole Inspection Summary

Manhole # S41A__028MH

Location Address: **413 1/2 n caroline st**

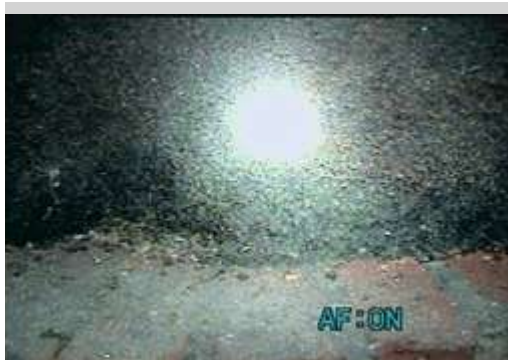
Defect 3

Condition: ☐ Sound ☐ Cracked ☐ Root Intrusion ☐ Deteriorated ☐ Leaks ☒ **Debris**

bench debris

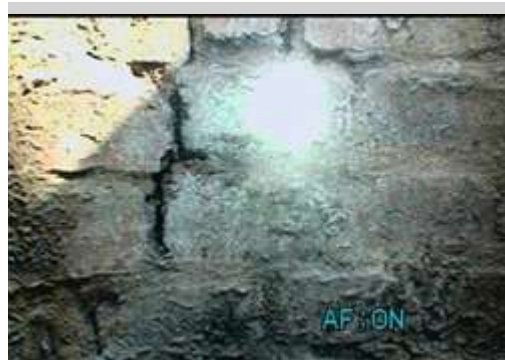
Defect 2

Condition: ☐ Sound ☒ **Cracked** ☐ Root Intrusion ☐ Loose Brick ☐ Deteriorated

corbel cracked

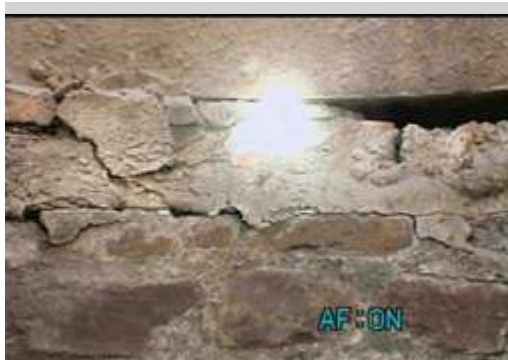
Defect 1

Condition: ☐ Sound ☒ **Cracked** ☐ Root Intrusion ☐ Loose Brick ☐ Deteriorated

Chimney cracked
frame adj

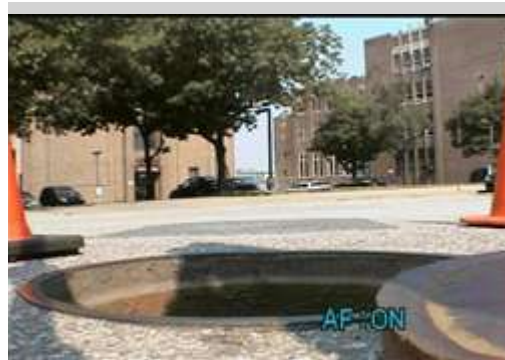
Defect 4

Condition: **Worn**

worn cover

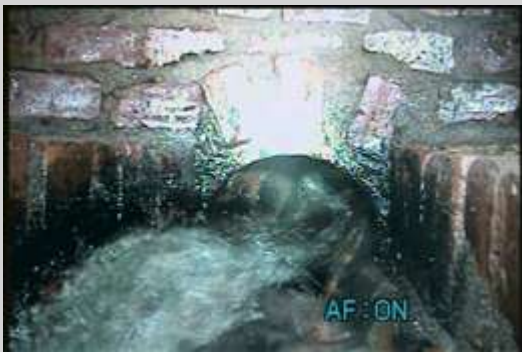
12 O'Clock Outflow

8 in. Circular Gravity Sewer
Pipe Out @ 12 O'Clock

Pipe Material: **Clay** ☐ Pipe Lined

Invert Depth: **10.70** (ft.) Flow Characteristics: **Fast**

Infiltration: **None** Pipe Seal Cond: **Unknown**

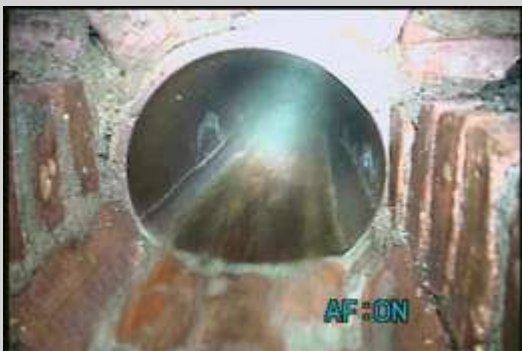
6 O'Clock Inflow

8 in. Circular Gravity Sewer
Pipe In @ 6 O'Clock

Pipe Material: **Clay** ☐ Pipe Lined

Invert Depth: **10.32** (ft.) Flow Characteristics: **Fast**

Infiltration: **None** Pipe Seal Cond: **Unknown**

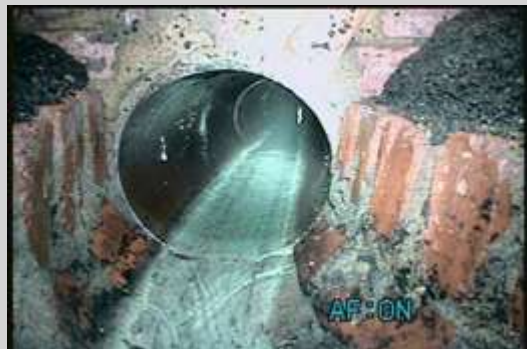
9 O'Clock Inflow

8 in. Circular Gravity Sewer
Pipe In @ 9 O'Clock

Pipe Material: **Clay** ☐ Pipe Lined

Invert Depth: **10.40** (ft.) Flow Characteristics: **Fast**

Infiltration: **None** Pipe Seal Cond: **Unknown**
